BRIGHAM REIMAGINED PROJECT PRESENTATION HEARING  
TUESDAY, JUNE 4, 2024  
7:00pm

## Section 1 Introduction

The town contracted with David Boehm from Engineering Ventures, a structural engineering firm with a specialization in adaptive reuse, to conduct an assessment of the building's structural integrity focusing on the foundation, the roof and the immediate site around the building. According to the engineer, the assessment was by no means an exhaustive structural review of the structure. Rather, it was a visual overview, with selected areas chosen for some basic calculations in order to get an idea of strengths and capacities that may exist within the structure. Even these areas may not be representative of un-reviewed areas, and some key items such as connections are beyond the scope of this report.

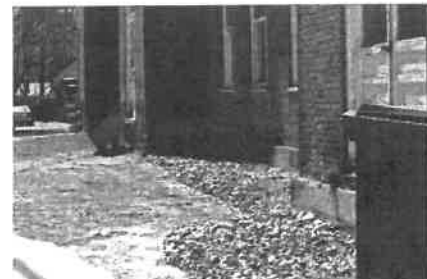
The site around the building is relatively flat, which has contributed to water problems around the foundations, and water and dampness in the basement and under the gymnasium. Work underway along the north half of the north foundation wall to add

crushed stone along the wall at grade is intended to help with erosion below the drip line from the eave above and improve drainage in this area.

- A more aggressive approach would be to install foundation drains if there is enough change in grade to be able to discharge to a lower area.

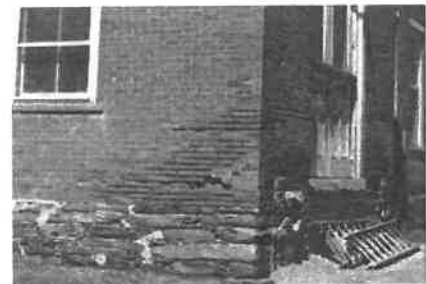
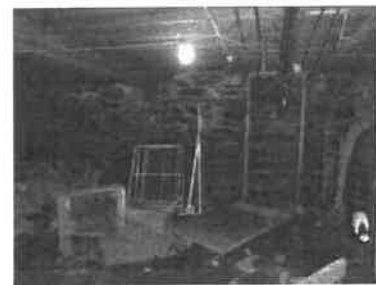
*Basement, Foundation, and Lower Gym Level Conditions.* The basement underlies all of the building with the exception of the gymnasium wing. Exterior walls are seen to be mortared stone where exposed and appear to be substantial in thickness. Smaller, laid-up stone is used inside, while larger more uniform stones are employed above grade outside. While there are some areas of localized failure or instability seen from the inside, much of these foundation walls appear substantially intact and suitable for continued use. Other areas of the basement walls are covered and should be exposed to further view conditions and to dry out these areas. Interior first floor supports are comprised of brick piers. Additional masonry walls divide some rooms in the basement and appear in good shape. The basement floor is a concrete slab in some areas and bare soil in others.

- Brick piers supporting the first floor are in reasonably good shape but need minor work.
- While there are some areas of localized failure or instability seen from the inside, much of these foundation walls appear substantially intact and suitable for continued use. Pointing and mortaring and relaying some stone would be required.
- The basement floor is a concrete slab in some areas and bare soil in others. A good vapor barrier and sound slab would be recommended.
- Interim steps to protect against heaving of the foundation walls might include temporary heat or insulation on the existing floors.
- Sills or wood in contact with the brick and masonry foundations may well be subject to rot and should be further investigated.

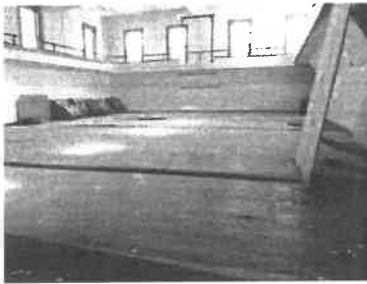
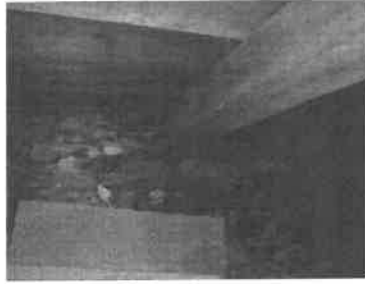
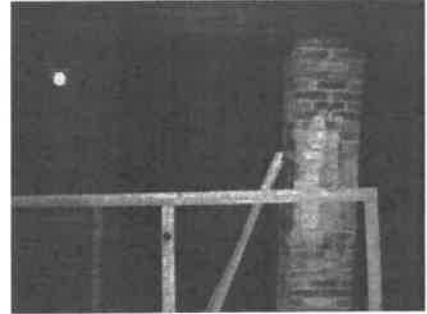
The lower level of the gymnasium wing is a split level; not as low as the

main basement floor, but well below the main floor level. The wood flooring has apparently swelled and buckled upward in several locations. The floor is built about a foot above the soil which underlies this wood gym floor. A solution here might be to remove the floor, place a concrete slab and then add a finished floor appropriate to any proposed use. Foundations are not expected to be much deeper than the basement floor. This is an issue as the building remains unheated through the winter. Heaving of these walls is likely which will loosen the stones and may lift floors, walls, and points of support.

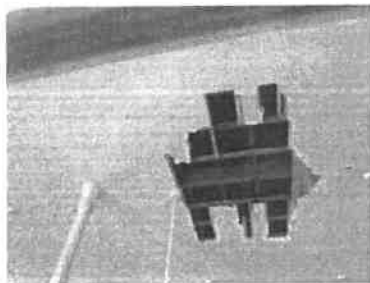
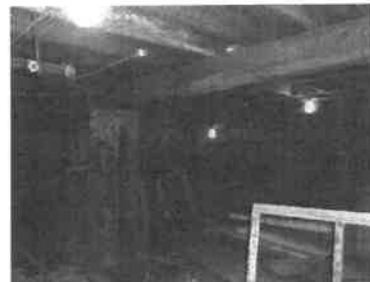
*Main Floor and Second Floor.* The structural elements are mostly covered and hidden in these floors/ceilings/walls although there is at least one exposed opening in the first floor ceiling. The structure that is seen in this opening (as well as the exposed structure in the basement ceiling) confirms joist and beam sizes that are described in the original specifications that are available for the building. This framing appears in sound condition although there may be water or moisture damage near exterior walls.

The gymnasium is characterized as a steel structure with heavy girders and beams supported by steel columns that are just inside the exterior walls. This structure appears in good conditions and supports the second floor classrooms above, and in turn, supports the roof of this wing of the building. The second floor framing in this area was not visible.

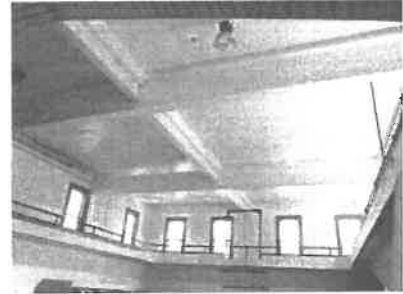
The front central entrance includes a wide staircase to the second floor. The stair appears somewhat out of level and plumb. A column has been added behind the staircase. This appears to be an added support to the main beam that probably exists at the top of the main floor staircase at the second level.

- The second floor framing in this area was not visible. This framing should be checked.
- The overall first to second floor stair capacity should be further reviewed.

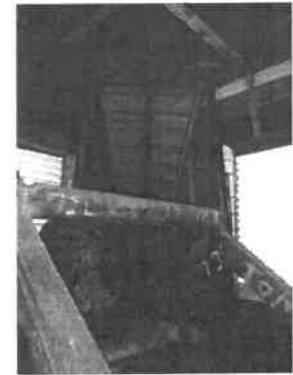
*Roof Framing.* The tower roof shows signs of past water damage and rot. Selected members have been replaced. Many original members appear adequate, yet some areas have rot and water damage that has not yet been repaired.

- Original framing members that have rot and water damage need attention.
- Joints and trusses in the south and west portions of the building require further analysis.
- Given the overloading of the first two trusses in the west wing attic, it is likely that the third truss has inadequate capacity and may experience more failure unless it is further reinforced.

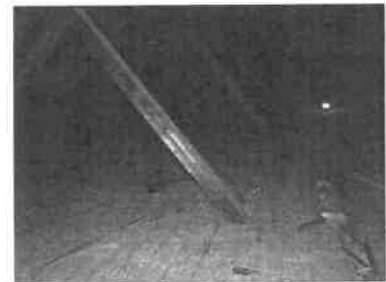
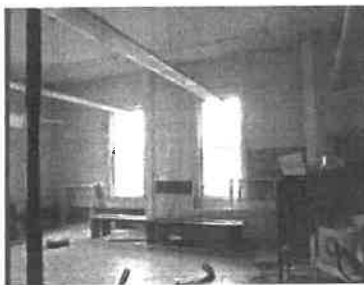
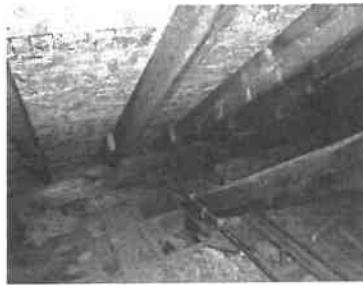
Over the south and west portions of the building, the roof is principally supported by five major trusses as well as by the four exterior walls. In the west wing, serious damage and failure occurred in at least two of the three major trusses in this west wing area. Cables have been installed along the full length of these two trusses to hold the building together.

Additional columns have been added, slightly inside the exterior walls, to further support these trusses down through the floors below to the foundation.

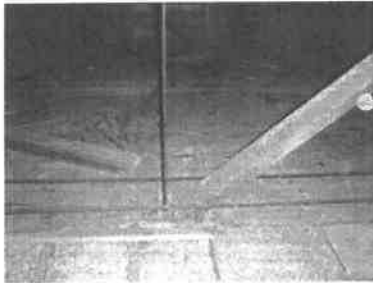
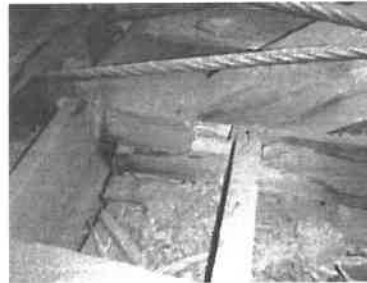
At a primary connection of one of these trusses, a portion of timber has sheared off completely, apparently under heavy stress, and in another location a key diagonal web member of a truss has simply fallen out of place and onto the attic floor, indicating most likely that the truss has had enough movement that a joint could separate to the point that it would fail.

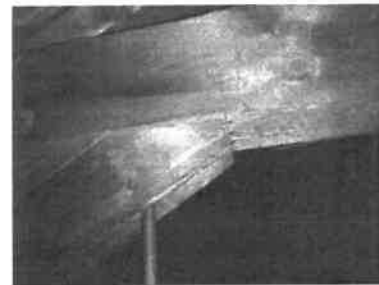
Other joints are seen with partial separations of the members. The third truss in the west wing attic has also had new columns added for more support but cables were not added to this truss. This truss carries somewhat different loading than the first two trusses as it is near the valley beams where the south and west wings meet.

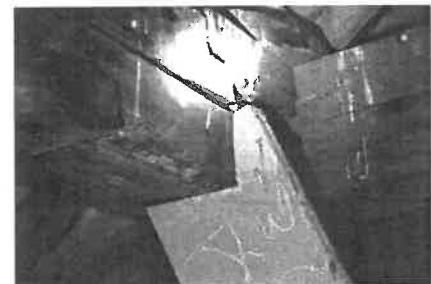
In the south section of the attic the two other major trusses span in the same direction, at similar spacing, and with similar configuration as in the west wing, but they support rafters and a ridge that are perpendicular to those in the west wing. Given this arrangement, the loads on these trusses are different than those in the west wing. There is evidence of some failure in these trusses, and there have been new supports and joint repairs made.

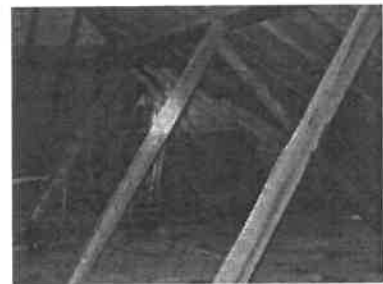
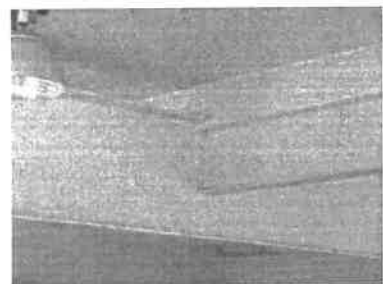
*Gym Ceiling/Second Floor.* The north wing roof depends on the steel structure of the gym ceiling/second floor. We find the main 33" steel beams that cross the narrow width of the gym and their supporting columns to be adequate for full current code snow loads coming down from above, and with a reasonable 60 psf of live load allocated to the second floor. However, the 17.5" steel beams that span between these 33" beams, and to the end walls of the gym, are overstressed when we apply loads according to the code. The basic issue with these 17.5" steel beams is that, rather than being snug under the gym ceiling where they could be laterally braced by the attic floor, they are dropped below the ceiling and appear to have a short stud wall above them up to the ceiling.

Even with bracing from the ceiling they would be somewhat overstressed. Without such bracing their capacity drops dramatically.
